**ASACUSA@SMI**

**25/5/2021**

# Cold bore parts arriving

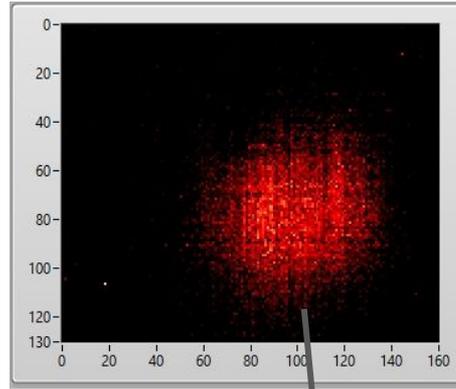
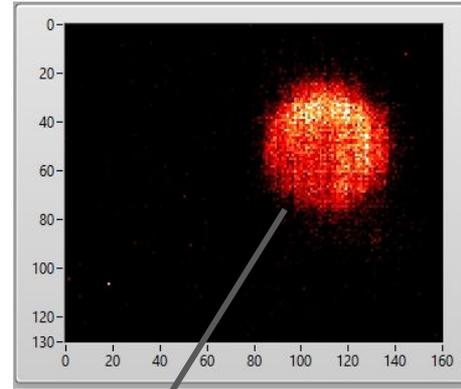
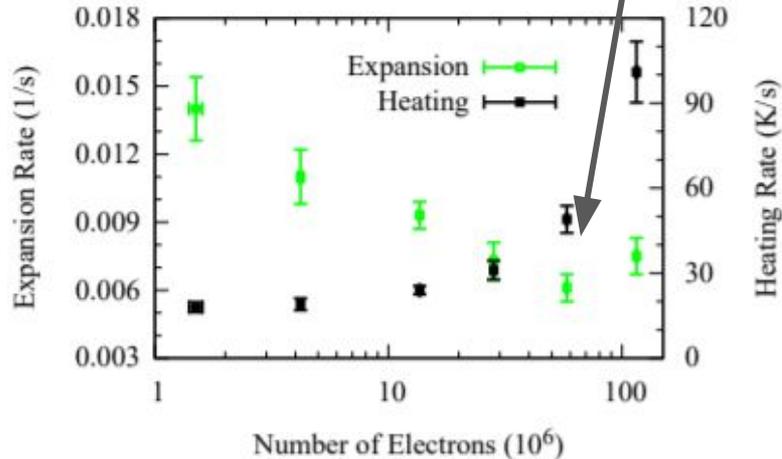
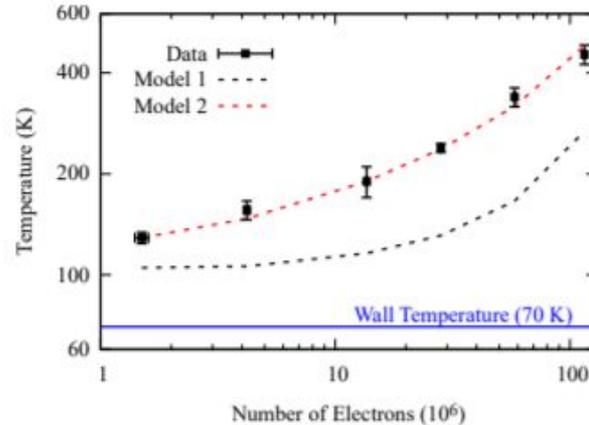
Misalignment measured:  
roughly 30 mrad (that's a lot)

Expansion rate measured:  
>0.02 s<sup>-1</sup> (much higher than in 2020)

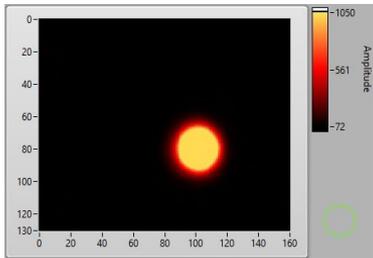
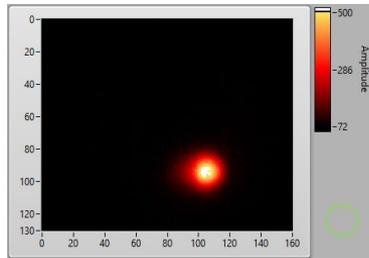
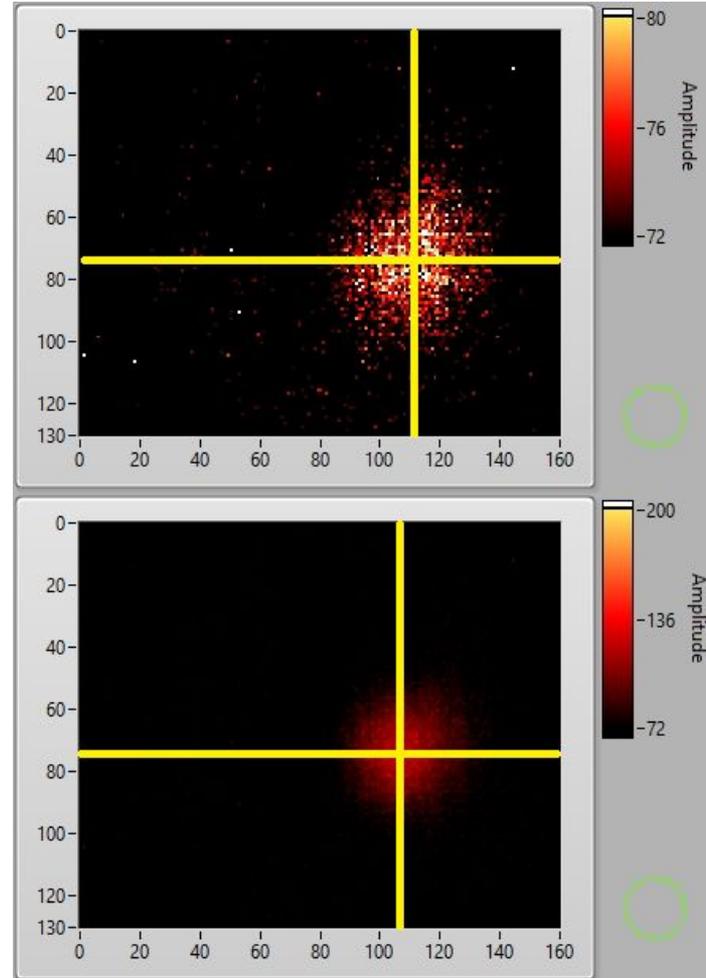
Cold bore temperature starts falling,  
eventually settles at 33 K (was 35 K)

Misalignment reduced by roughly 10x

Observed marked improvement in RW  
compression while tuning near  $dx, dy = 0, 0$   
→ some very dense plasmas

Adjust alignment knobs towards 'easy'.

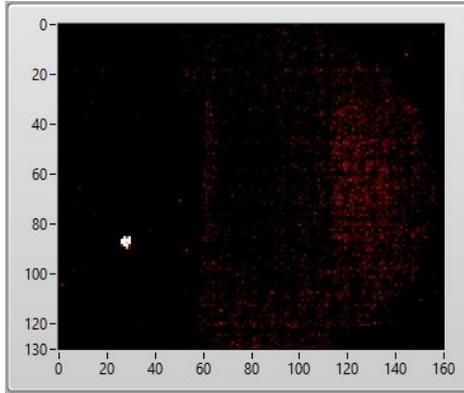
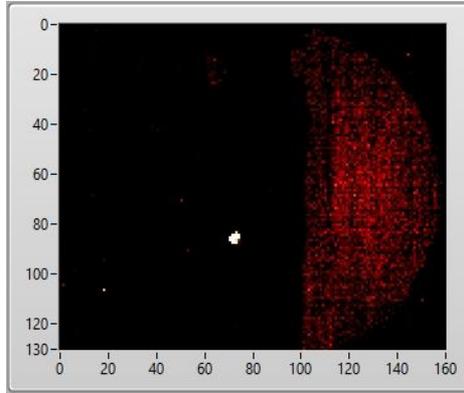
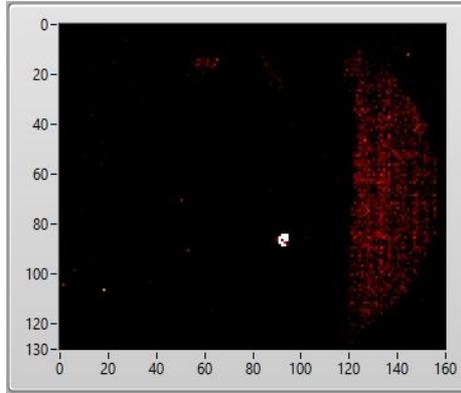
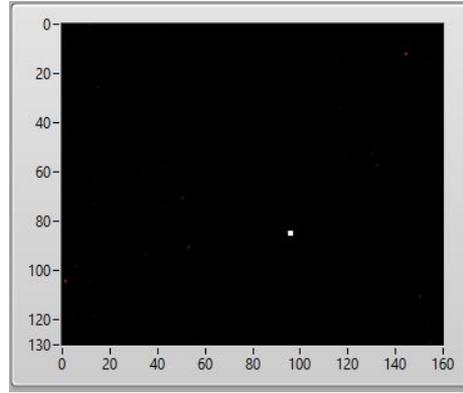
While we were tuning the trap alignment, the MCP started sparking.  
Soon after, the e-source shorted to ground. It could no longer be biased.  
Visual inspection showed that the e-source and MCP, normally inserted one at a time into the beamline, were now overlapping.

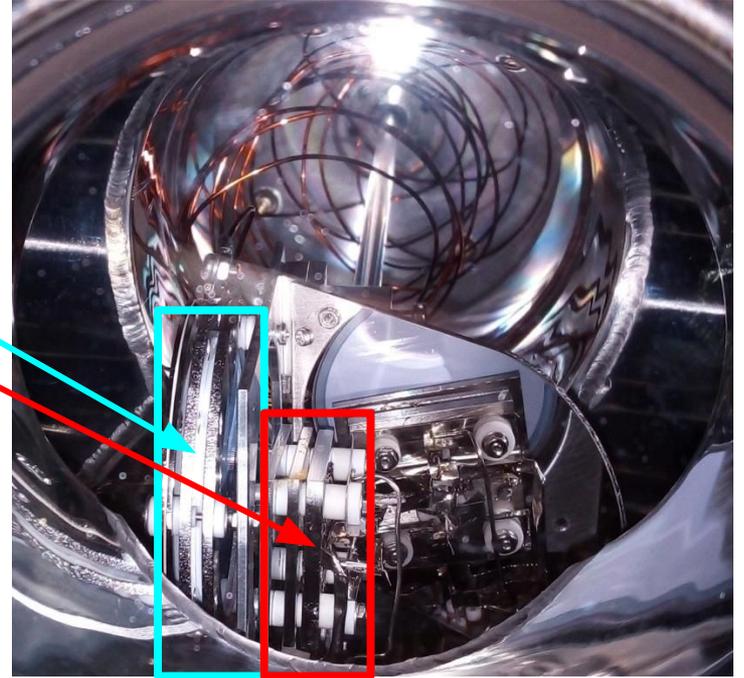
Somehow the MCP  
and the e-source  
overlapped and got stuck together

Confusing because

1 This should be impossible (interlocks)

2 They did not fail simultaneously

--MCP sparking got progressively worse over several cycles, then e-source failed

3 The MCP stick appears to be hyperextended

--raising the actuator does not raise the detector

→ Stop plasma work, warm up cold bore

→ Work on proton source and transfer line
